DALI-Gateway S64 KNX

DALI-Gateway S128 KNX

Firmware Update

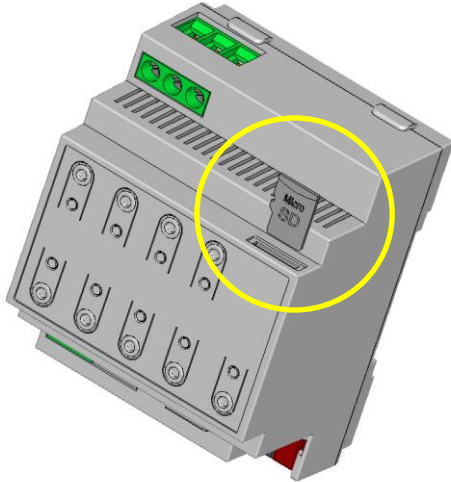
For update purposes, the DALI Gateways S64 and S128 KNX have an SD card slot on the upper right edge of the device. When delivered, the opening of the slot is covered with an adhesive label. To insert a SD card, the label must be carefully removed.

After removing the label, please insert the SD card carefully into the de-energized gateway in such a way that the row of contacts on the card points downwards or the recess on the card is aligned to the left. Make sure that the card is not tilted and not inserted into the slot at an angle. At the end you will feel a slight pressure as the row of contacts snaps into the contact hole.

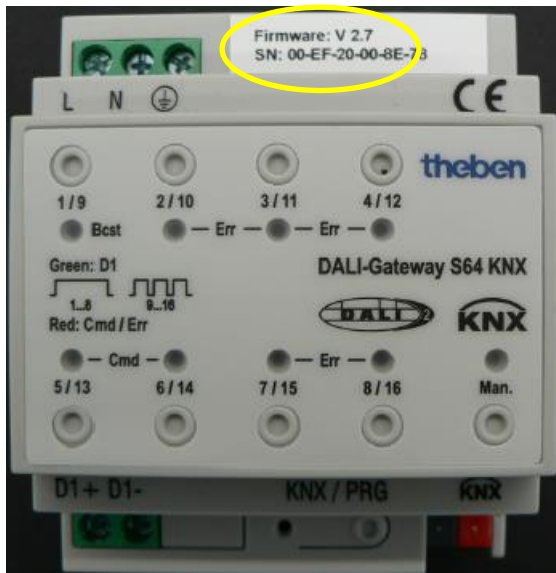
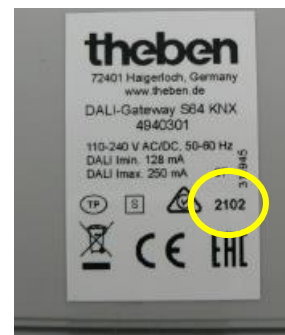
3.1 Information Firmwareversion Delivery condition

Manufacturing date 2102 = Year 2021 / Week 02
